Manhole Inspection Summary

Manhole # S29QQ_001MH

Insp Date: **5/21/07 9:12 AM**

Location Address: **2701 FALLS RD**

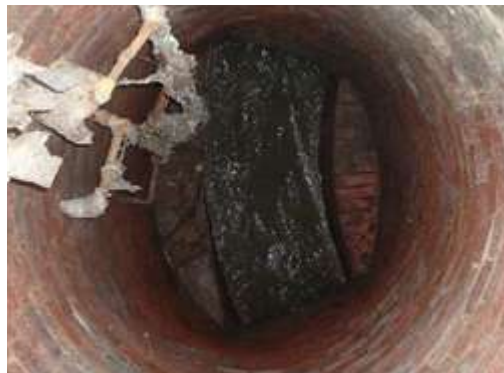
Top View

Corroded steps. Evidence of surcharge - Bench debris.

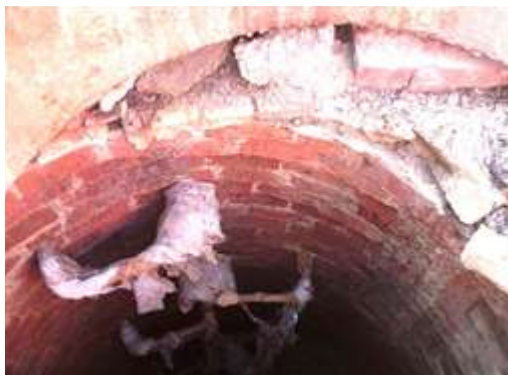
Defect

Frame leaks. Frame offset. Adjustment deterioration, loose brick and infiltration. Barrel infiltration- other side.

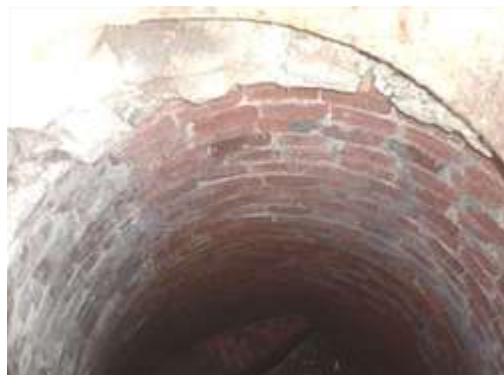
Defect

Frame leaks. Frame offset. Adjustment deterioration, loose brick and infiltration. Barrel infiltration.

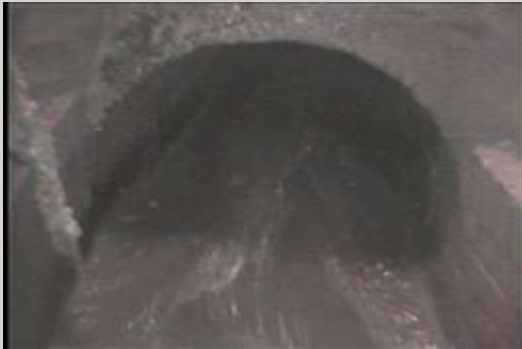
27 in. Circular Gravity Sewer Pipe Out @ 12 O'Clock

Infiltration: **Evidence** Pipe Seal Cond: **Unknown**

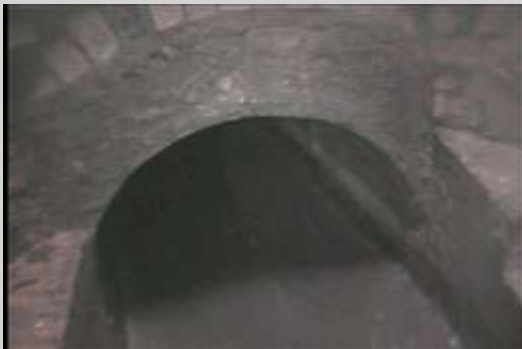
27 in. Circular Gravity Sewer Pipe In @ 5 O'Clock

Infiltration: **Evidence** Pipe Seal Cond: **Cracked**

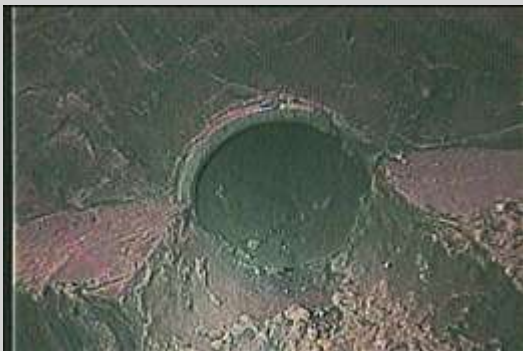
6 in. Circular Gravity Sewer
Pipe In @ 7 O'Clock

Deposits: ☐ None ☒ **Mud** ☐ Sludge ☒ **Debris** ☐ Grease

Silt Depth: **0** (in.) Deposits Extent: **Light**

Infiltration: **Evidence** Pipe Seal Cond: **Broken**
